SUBJ: Flight Controls

This Special Airworthiness Information Bulletin (SAIB) advises registered owners and operators of all **The Boeing Company Transport Category Airplanes** of an airworthiness concern regarding inadvertent actuation of the flight deck controls.

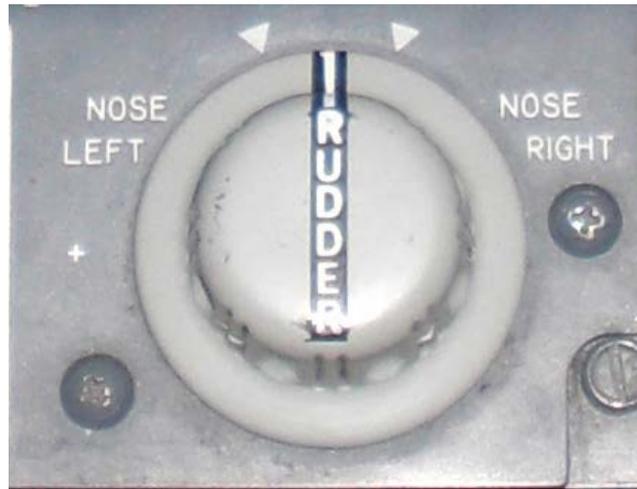
Figure 1 – Rudder Trim Switch

During the investigation of this incident, numerous aisle stand configurations were identified due to the multitude of supplemental type certificate installations and significant variability in the Boeing-delivered configurations. On the incident airplane (Model 737-700), the rudder trim switch is in approximately the same location as the flight deck door control switch on the operator's Model 737-500 airplane. This creates a potential for confusion when pilots transition between aircraft. Positive training on one model can become negative when the pilot transfers to a different model. Although the rudder trim switch (Figure 1) and flight deck door control switch (Figure 2) are different in size and shape (cylindrical vs. blade shaped), and the flight deck door unlock side of the switch must be depressed before turning, the general feel (spring force) to actuate the switches is similar; both are spring loaded to the center position. In this incident, the negative transfer error allowed the pilot to think he had operated the correct control, and the similarity of the control's operation exacerbated the situation.

Having a consistent position for the rudder trim switch is paramount because it provides a direct input to the aircraft rudder and can induce both yaw and roll into the aircraft flight attitude. Because both the rudder trim switch and the flight deck door control switch have a similar feel and action (turn and hold), a standard location and sufficient separation between these controls is recommended. Placing the controls in the recommended locations is consistent with most Boeing-delivered airplanes and creates a distinctive reach posture, provides sufficient separation in relation to reach direction from both seats, and provides adjacent tactile landmarks. This includes the railing in the corner of the aisle stand and the guarded stabilizer trim switch located between the rudder trim switch and the flight

1. Place the rudder trim switch in the center column as far aft as possible.
2. Place the flight deck door control switch in the far right column (first officer side) aft position.
3. Do not place the flight deck door control switch in the center column.

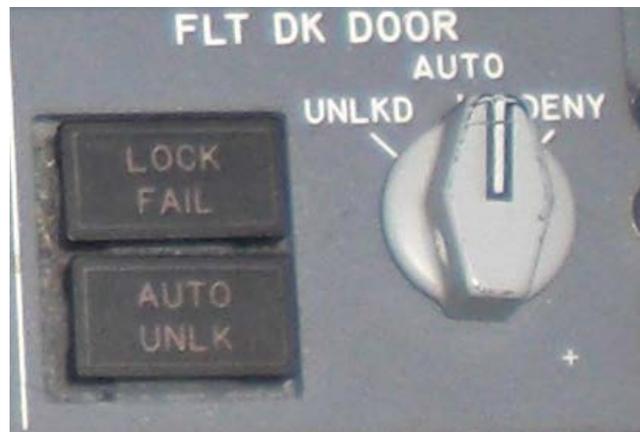
Figure 2 – Flight Deck Door Control Switch

In response to this incident, Boeing analyzed modifying the shape of the flight deck door control switch; however, they determined the position of the switch is more important than the shape of the switch from a human factors perspective. Position of a switch that affects pilot reach/posture provides better feedback to the pilot than the shape of the switch that the pilot feels. Boeing determined the most important factor to minimize inadvertent activation of the control switches is aisle stand configuration consistency within an operator's fleet.
